# TMS320F2837xS Real-Time MCUs Silicon Errata

## Silicon Revisions C, B

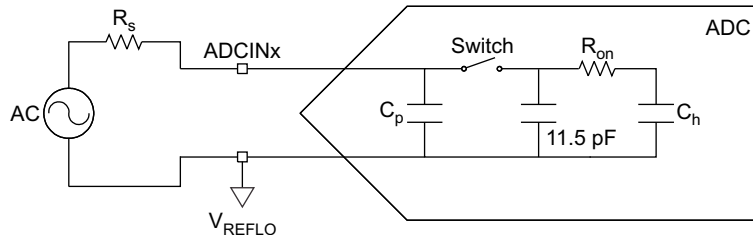
**Figure 4-1. Single-Ended Input Model**

The ADC input model should be used to select the sample-and-hold (S+H) duration for each ADC input. For the revisions affected, if the currently converting channel is an even-numbered channel and the previously converted channel was an odd-numbered channel (or vice versa), then the 12-bit input model will not accurately predict ADC input performance. Under these conditions, an additional capacitance should be added to the model. This capacitance has a value of 11.5 pF and should be placed between the S+H switch and  $R_{on}$  as shown in Figure 4-1.
